## White Paper: Testing Building Envelope Systems Using Infrared Thermal Imaging

Written by  
John Snell and Rob Spring, P.E.

# Testing Building Envelope Systems Using Infrared Thermal Imaging

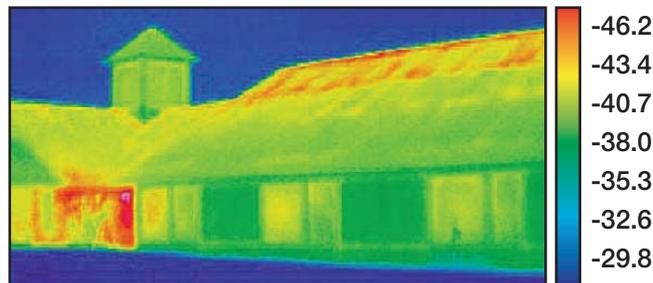
Image 1: The nursing home with a poorly designed roof/ceiling insulation system had many problems, including excessive heat loss during the winter months and extensive ice damage due to melting snow. The thermograms helped the owners negotiate a settlement with the architects and contractors.

Often the problems – as well as their causes and consequences – simply cannot be seen until after costly damage has been done. At that point the only recourse may be extensive, costly reconstruction. For example, the commercial building in Image 1, a nursing home, had extensive problems resulting from a poorly designed roof/ceiling insulation system; these included excessive heat loss during the winter months and, as a result, extensive ice damage due to snow melt. Hundreds of thousands of dollars were spent in various, poorly planned attempts to correct the underlying causes. In the end the owners simply lived with the continued problem because corrective actions were deemed too expensive. Despite this unfortunate resolution, the thermograms helped the owners negotiate a financial settlement with the architects and contractors.

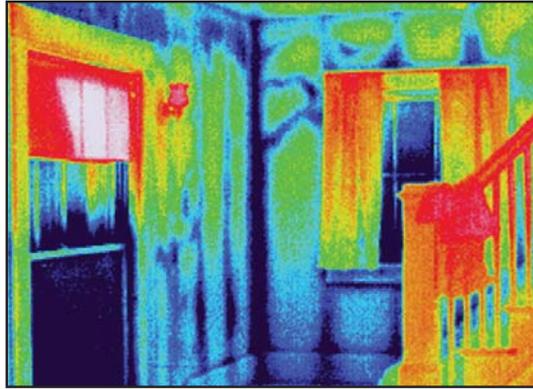
Image 2: When conditions are right, it is possible to locate missing or damaged insulation, such as this poorly installed injected foam in a residential building.

It is essential to know the type of insulation in the building and construction details, including how the insulation was installed. Insulation may be in place but not performing; often a destructive evaluation is warranted to establish baseline conditions or understand the exact construction detail. Each type of insulation has a characteristic thermal pattern. Image 2 shows a classic pattern associated with injected foam insulation in a wood-framed wall. This type of insulation, a soft foam, is susceptible to shrinkage and cracking when poorly installed.

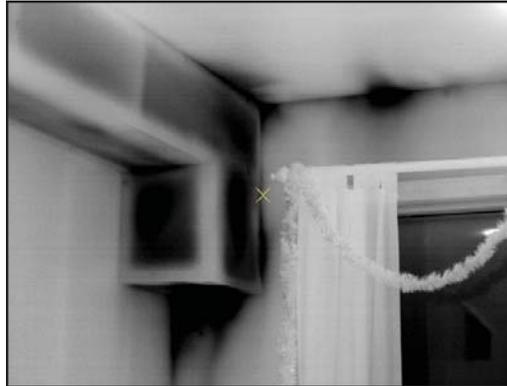
**Image 3:** The improperly installed fiberglass yields an irregular thermal pattern. The resulting cold spots commonly host wall stains or mold growth.

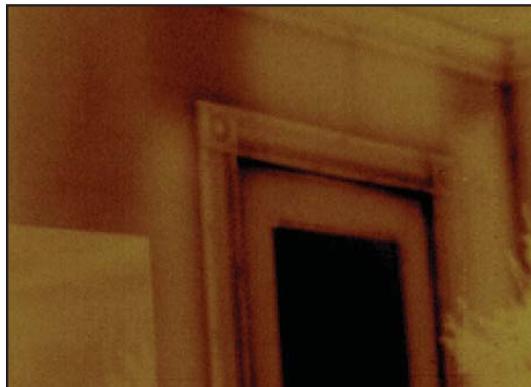
**Image 4:** Properly installed cellulose provides excellent insulation. However, quality problems can occur due to poor installation (with missed areas) and due to settling over time.

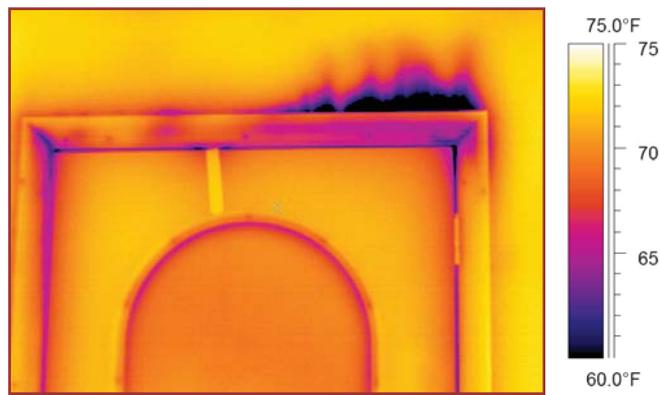
Image 5: Many types of insulation are susceptible to air infiltration. The fiberglass shown here does not stop air flow through the wall section.

Most types of insulation are not effective at reducing air movement through the thermal perimeter. Good construction practice includes interior air sealing; if this is not in place effectively, air can move through the interior and exterior surfaces and through the insulation. Unfortunately, fiberglass is particularly susceptible to this problem. Thus, while the insulation may be present, it does not perform as expected when the building is under a pressure gradient. Image 6 shows the impact of warm air leaking out of this commercial building. This will typically go unnoticed until the fuel bill is paid.

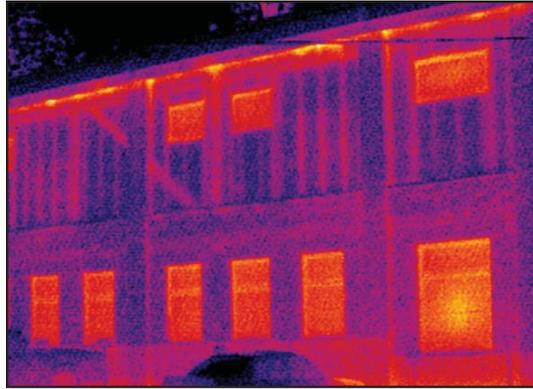
Image 6: All the framing and insulation is clearly visible in this commercial building. Normal pressure differences on the top floor result in air leaking past the envelope through various pathways.

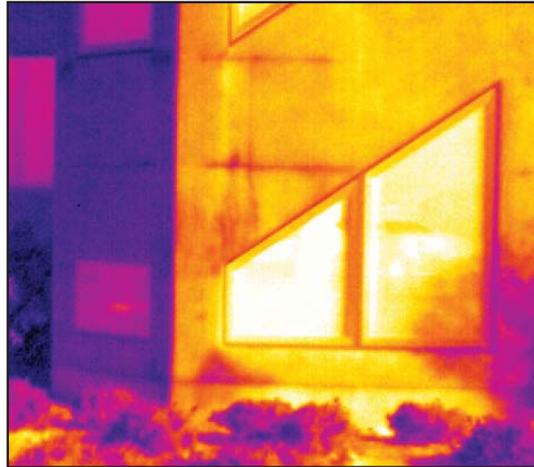
Image 7: EIFS construction is particularly susceptible to water intrusion resulting in both mold growth and wood rot problems.

Thermography is an invaluable tool to locate moisture in EIFS. Inspections are best conducted in the early evening from the outside after a sunny day with little or no wind. It may also be possible to locate moisture from inside during cooling or heating conditions. The expanded foam insulation boards tend to become more absorbent to water over time.

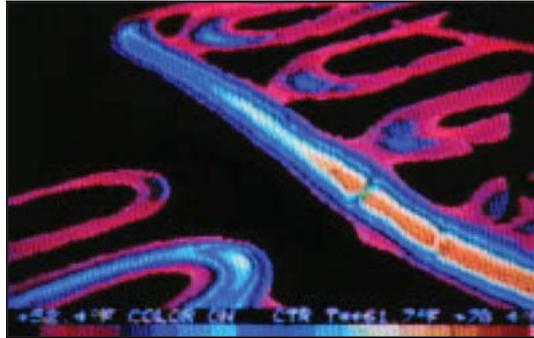
Image 8: Hydronic heating coils embedded in a concrete floor show up in this thermal image.

Heating coils are being used more and more either to keep outside walkways or entrance ramps snow free or to provide heat to areas and rooms via hot water or electric cables. Thermography provides a quick way to verify location and performance of these subsurface devices. Typically the thermal pattern shows up very clearly even when the heat source is embedded in several inches of concrete. Similarly, water pipes in wall sections can usually be located quite readily.

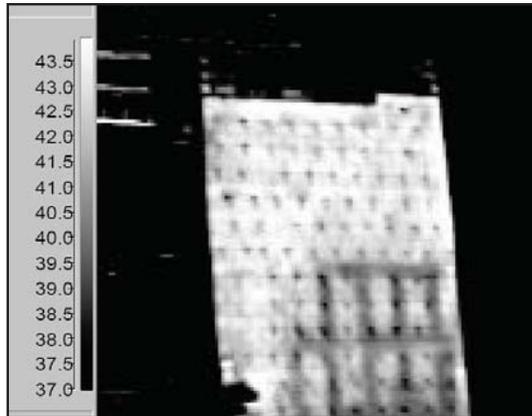
Image 9: This block wall is not uniformly grouted as was specified, leading to severe structural problems. Image courtesy Phil McMullen.

No area of application is more important these days, particularly in commercial buildings, than the verification of construction details and performance. Thermography is being used with great success to verify bond beams and placement of reinforcing in concrete masonry unit (CMU) walls as well as structural elements of pre-cast, tip-up walls. How? The solid portions of the wall change temperature more slowly than the rest. The inspection can be conducted anytime the wall is in a thermally transient condition — typically in

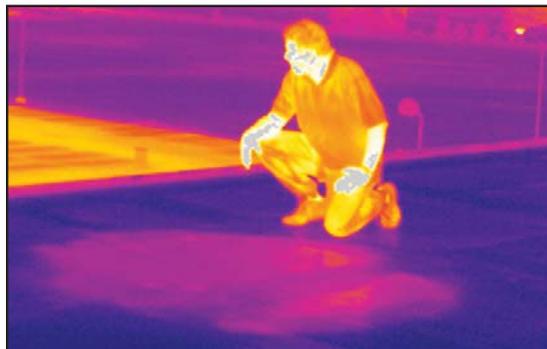
Image 10: The wet insulation in the roof system shows up clearly due to its greater thermal capacitance.

The inspection of flat roofs, especially built-up roofs (BUR) has been proven for a number of years. The technique allows for the detection of moisture trapped in a roof system; over time this moisture leads to the pre-mature degradation of the roof. The moisture appears warmer at night after a sunny day due to its greater thermal capacitance.

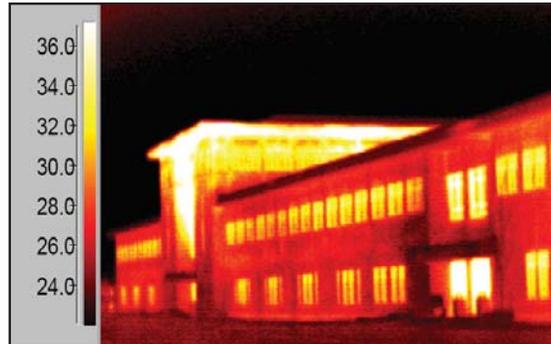
Image 11: During the commissioning of this building thermography revealed an extreme problem involving exfiltration through the soffit. Courtesy Phil McMullen.
